Release Note

MPI/XMP

Firmware and Library

XMP Firmware Version: 430B1
 MPI Library Version: 20021212.1.9

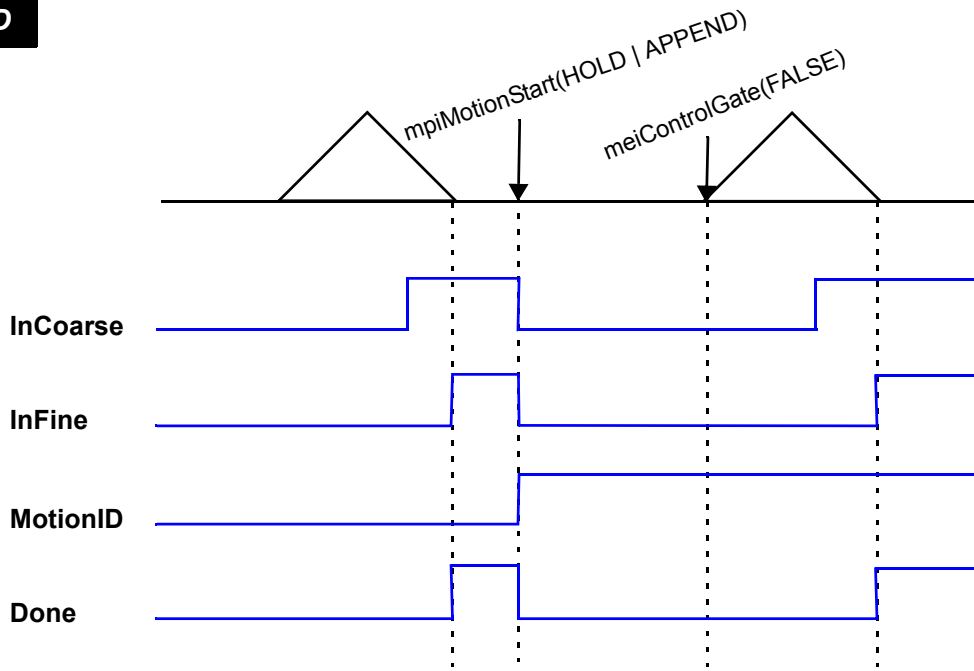
OLD

Please see the diagrams below.
