Release Note

MPI/XMP

Firmware and Library

XMP Firmware Version: 459B1
 MPI Library Version: 20030620.1.1

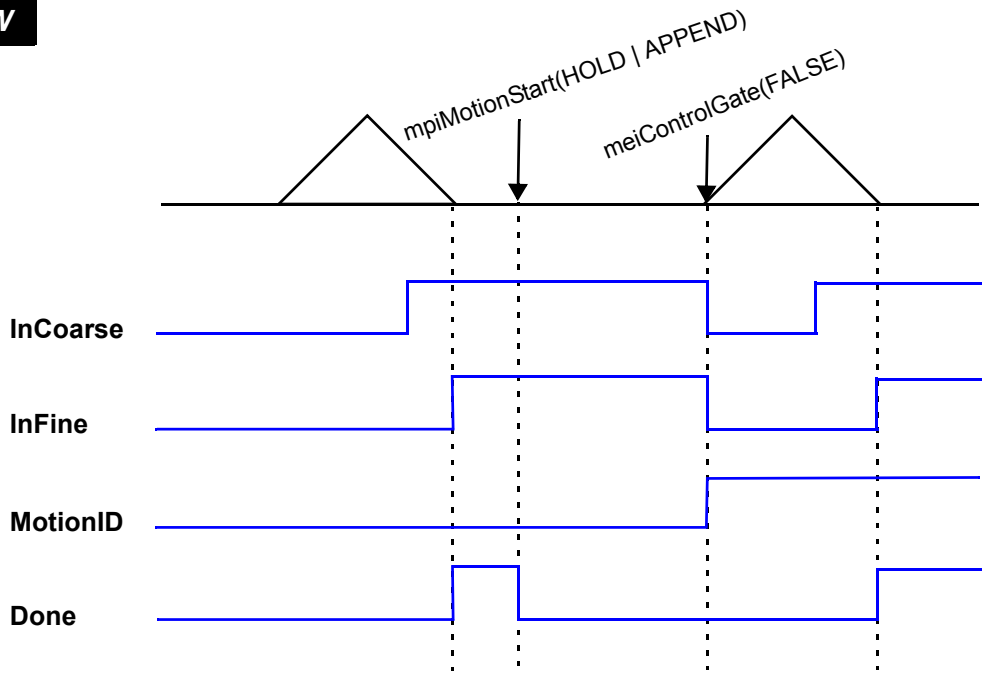
The MotionDone status will be cleared before updating the MotionID.

Please see the diagrams below.
